**SAS Superstructure**

Daily Diary Report by Bid Item

Contract No.: 04-0120F4

Diary #: 603 Const Calendar Day: 16 Date: 20-Jun-2012 Wednesday

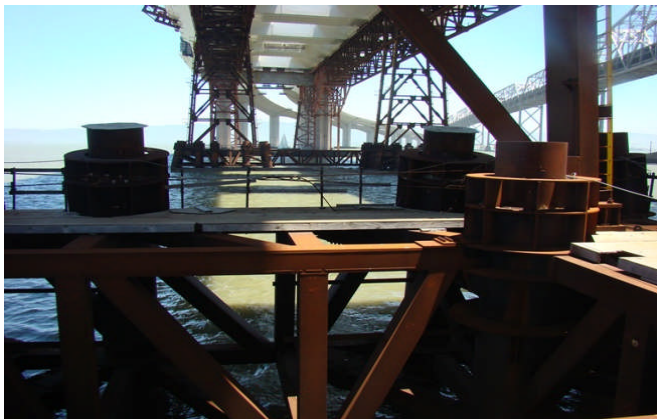
Temporary tower foundation on the W-Line where a scanning control point may be placed.

- Began to explore the option of having the Leica C10 scanners occupy points on the temporary tower foundations to complete the scanning survey before load transfer. The next phase of this survey is from the bottom of the truss, YBI, and multiple foundations in the water.

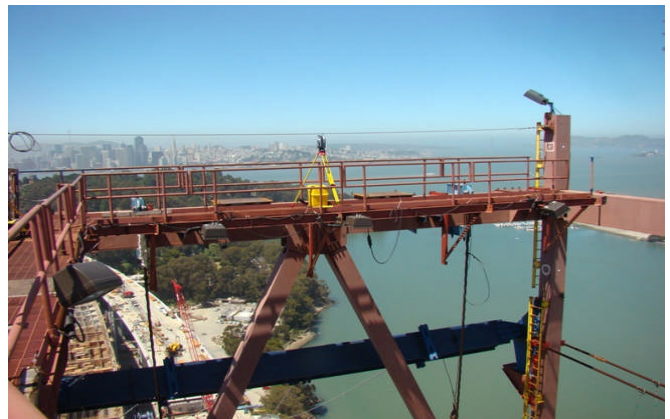
The Trimble S8 total station placed on Scan control point 301 to prepare for tomorrow's survey to place coordinates on the point.

- Began to prepare for surveying the scan control point 301 which is located on top of the west end walkway of the erection tower. Mobilized prisms, tribrachs, and tripods on top of the erection tower. Also set up the targets on control points E2 and E3 to face TWL270 which is located on the existing 1 pier. To reiterate TWL270 is the vertical benchmark for the SAS superstructure. See the photo below for more details.
